35 MLD Sewage Treatment

PANIPAT, HARYANA

The Problem

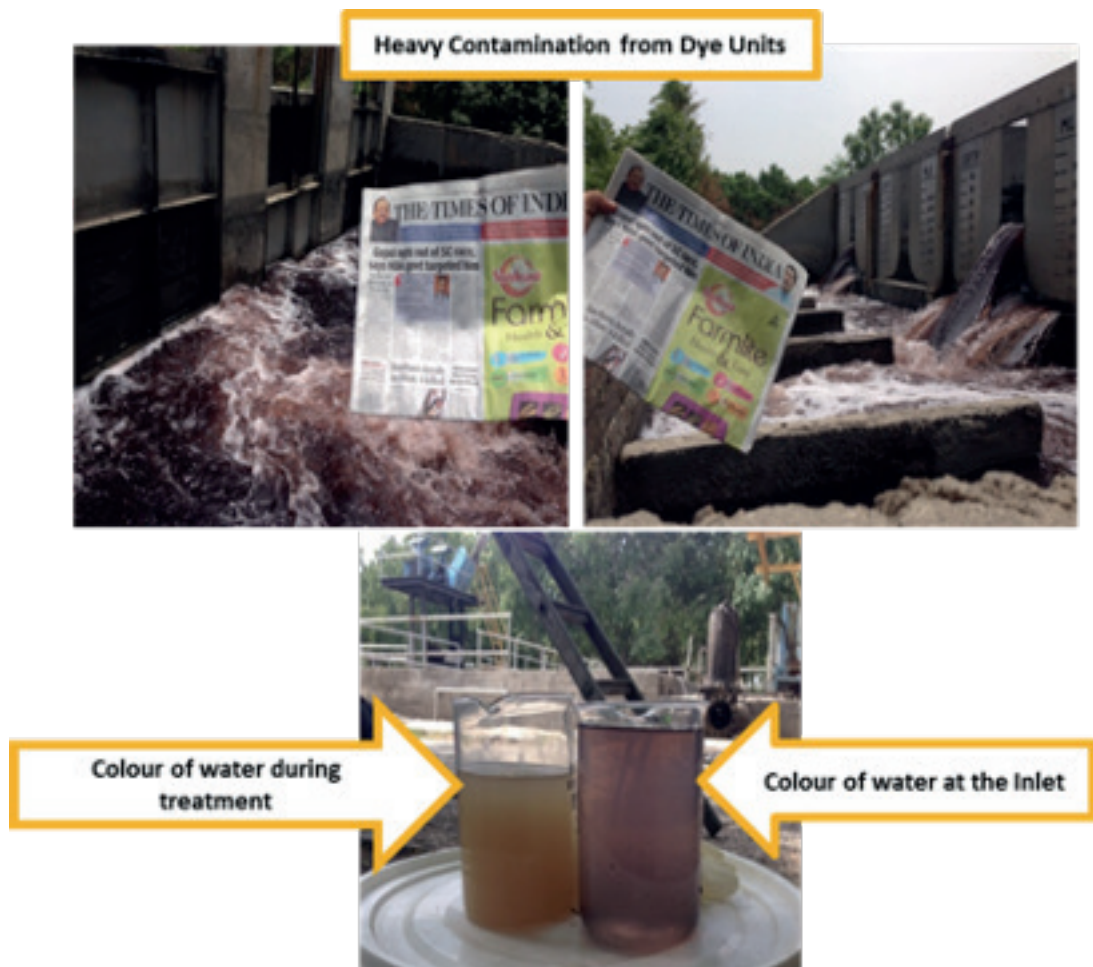
Figure: Level of colour contamination before and during treatment

Sludge in Final Polishing Units was 16 inches thick. Not been cleared for five years approx.

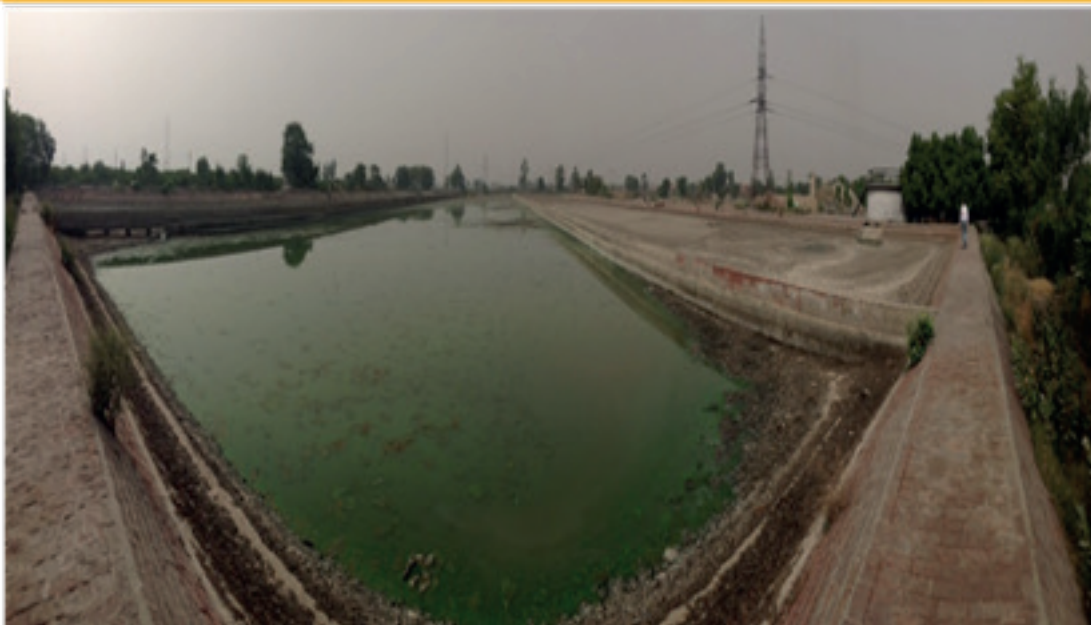
Figure: Sludge reduction in the polishing lanes
