Village Ponds in Jarauli

KARNAL, HARYANA

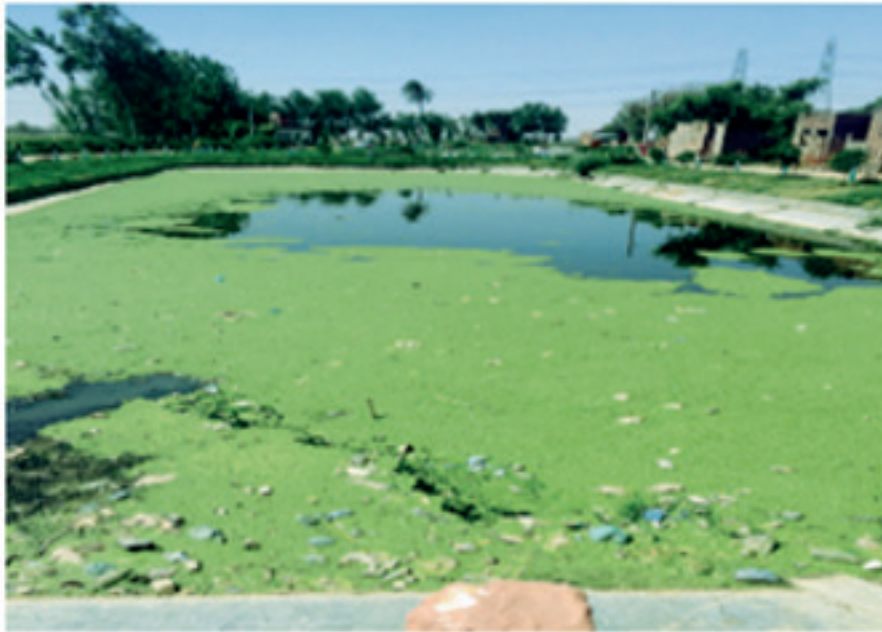
Pond Before Treatment
as on 21st April 2015

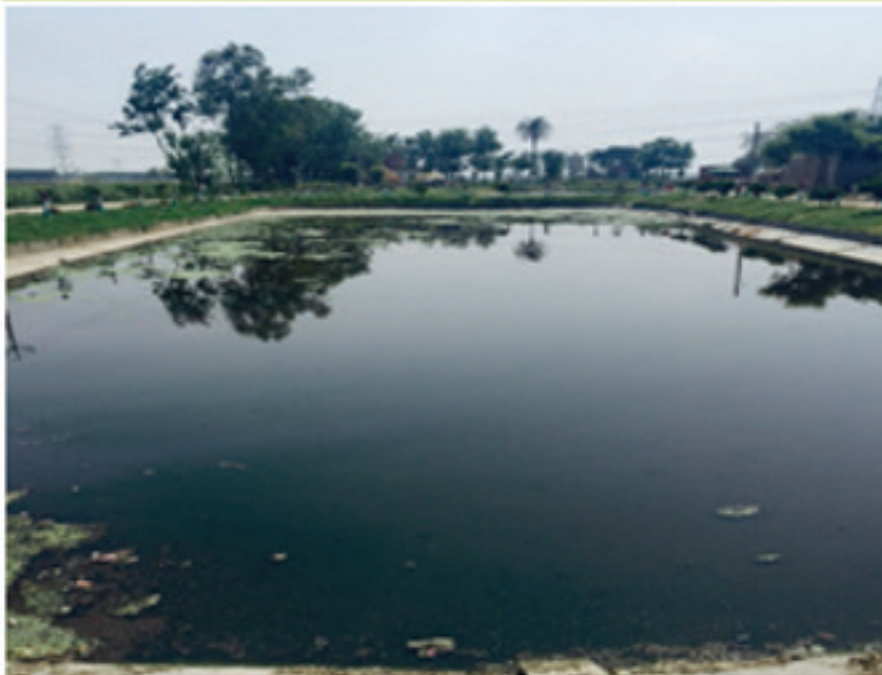
Pond After 2 Weeks of Treatment
as on 5th May 2015

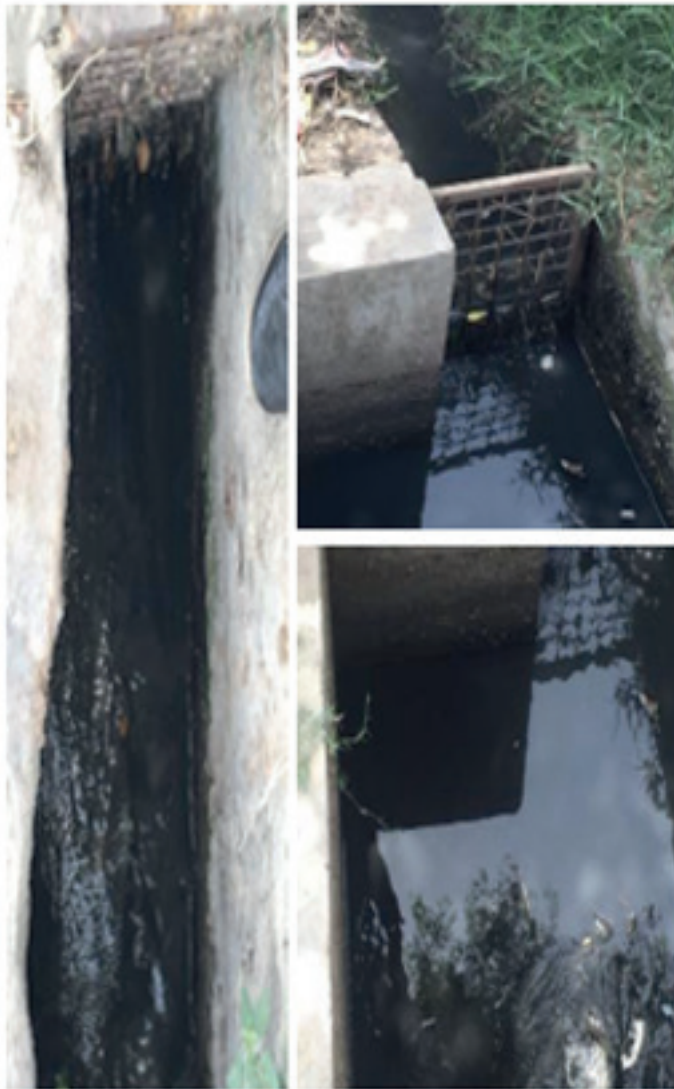
**Comprehensive Cleaning of the
Drains undertaken by Quash**

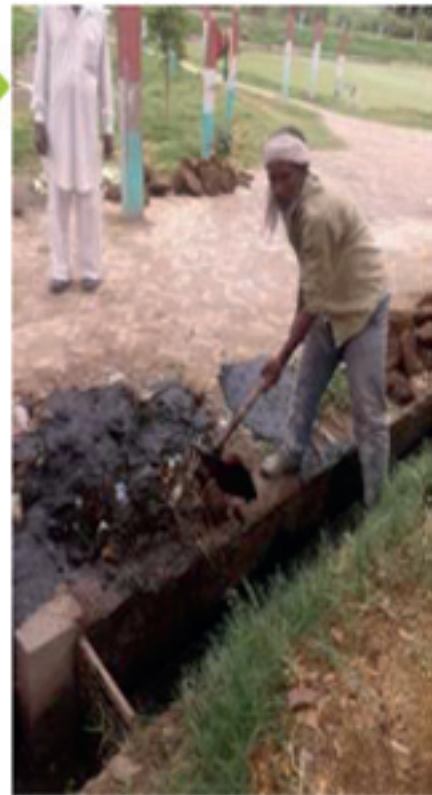
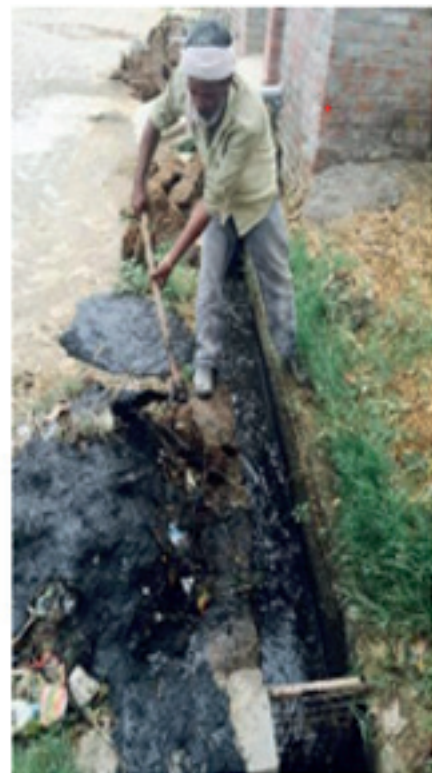
**Status of blocked drain leading to
pond before treatment**

Figure: Cleaning operations undertaken by Bio2pure

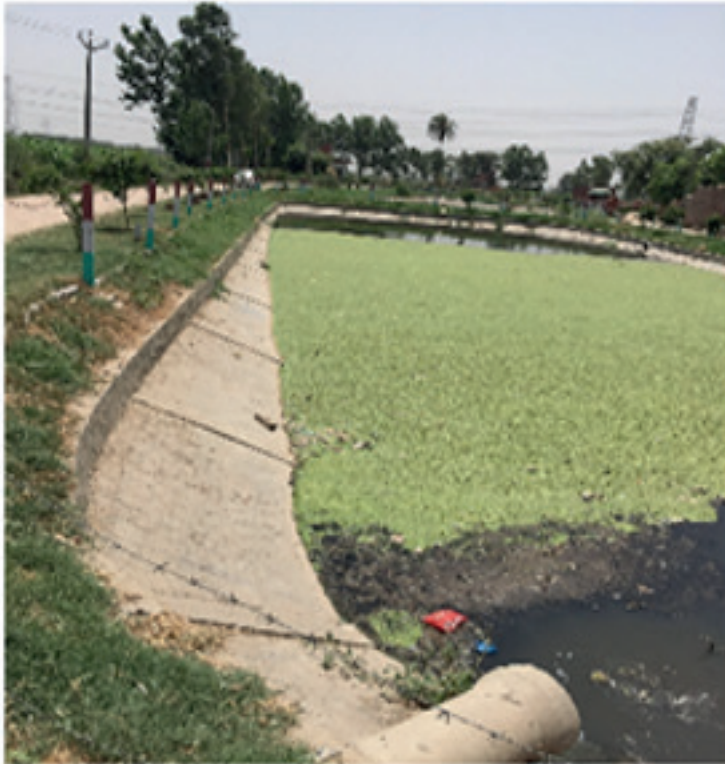
**Pond 1 (Before
Treatment)
as on
11th June 2015**

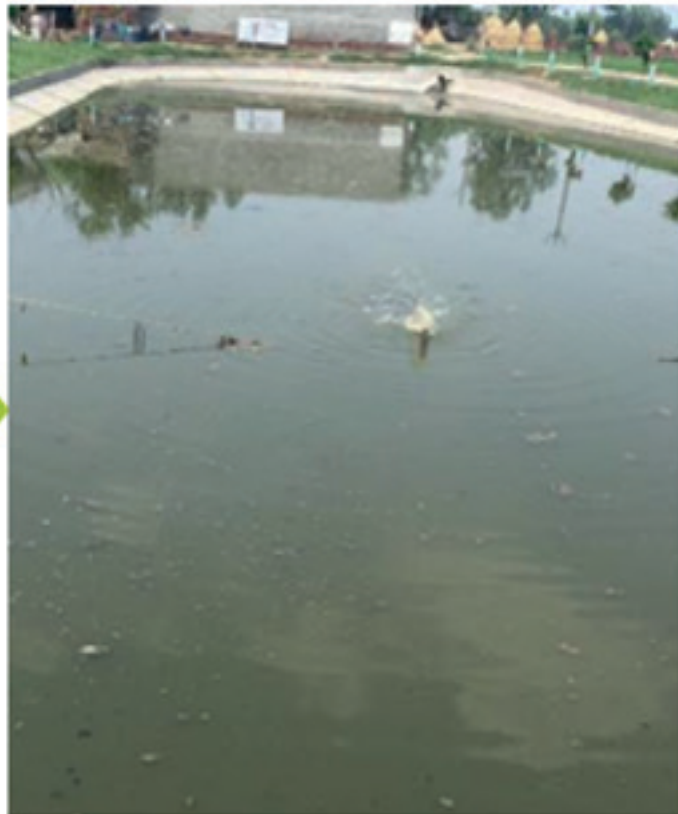
**Pond 1 (After 9 days
of treatment)
as on
20th June 2015**

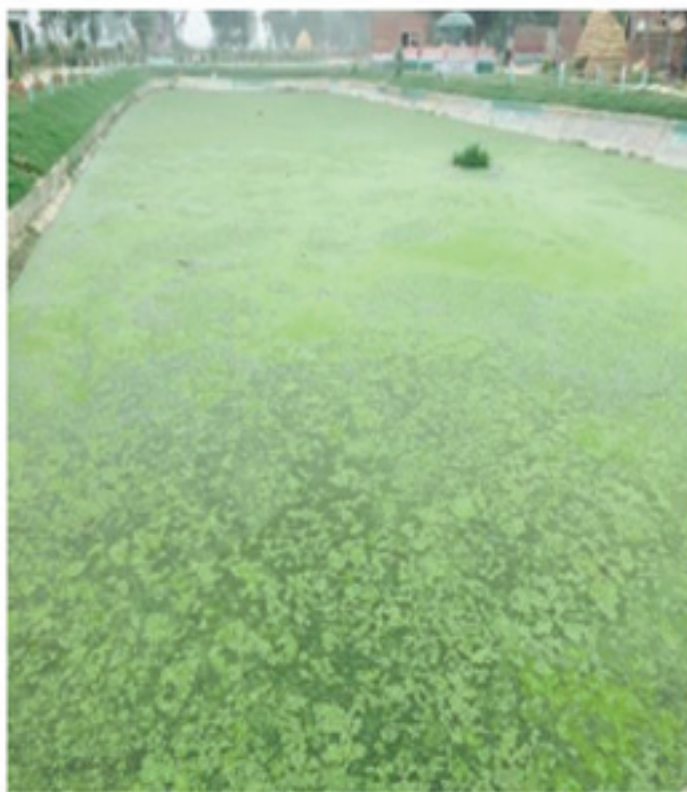
**Pond 2 (Before
Treatment)
as on
11th June 2015**

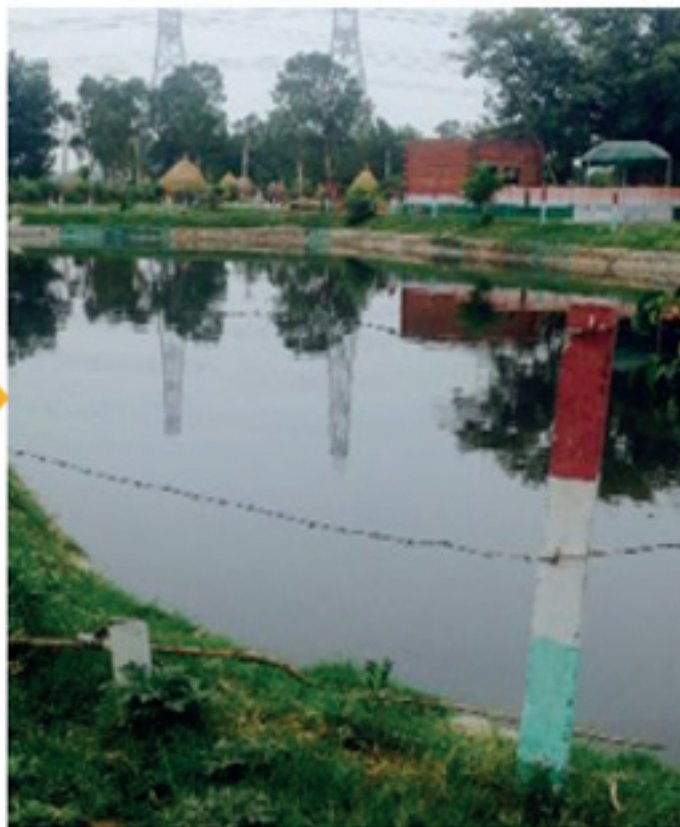
**Pond 2 (After 9
days of treatment)
as on
20th June 2015**

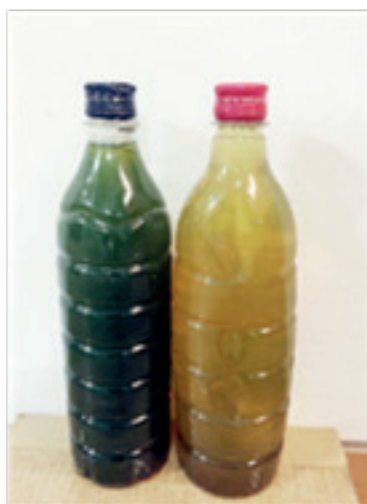
**Sample taken on
11th June 2015**

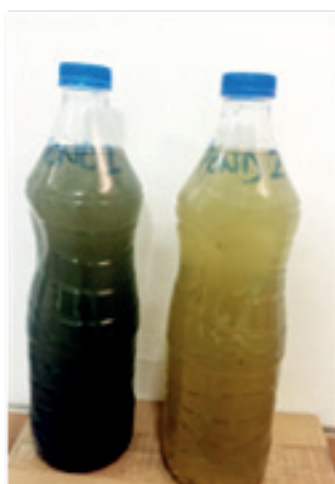
**Sample taken on
18th June 2015**

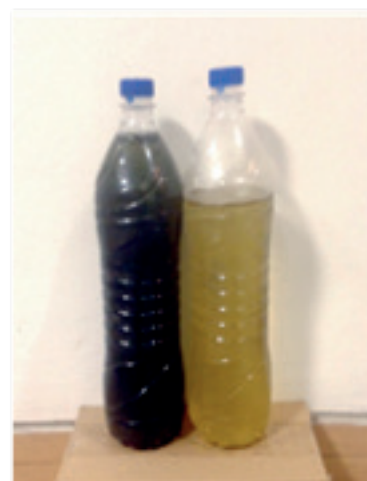
**Sample taken on
23rd June 2015**
