35 MLD Sewage Treatment

PANIPAT, HARYANA

The Problem

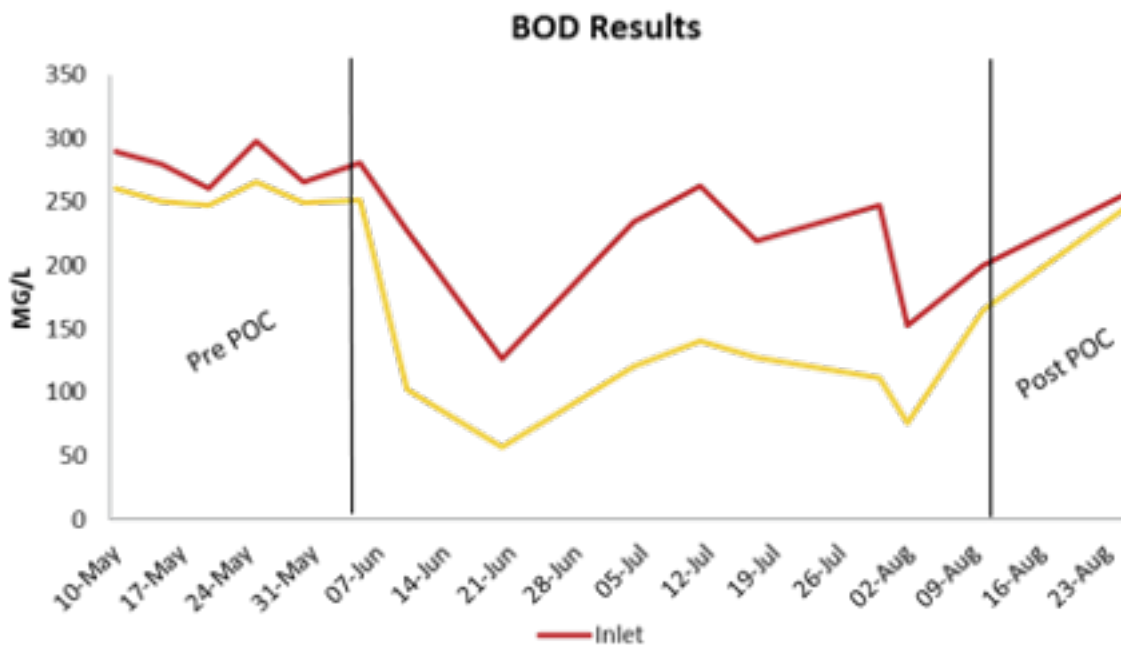
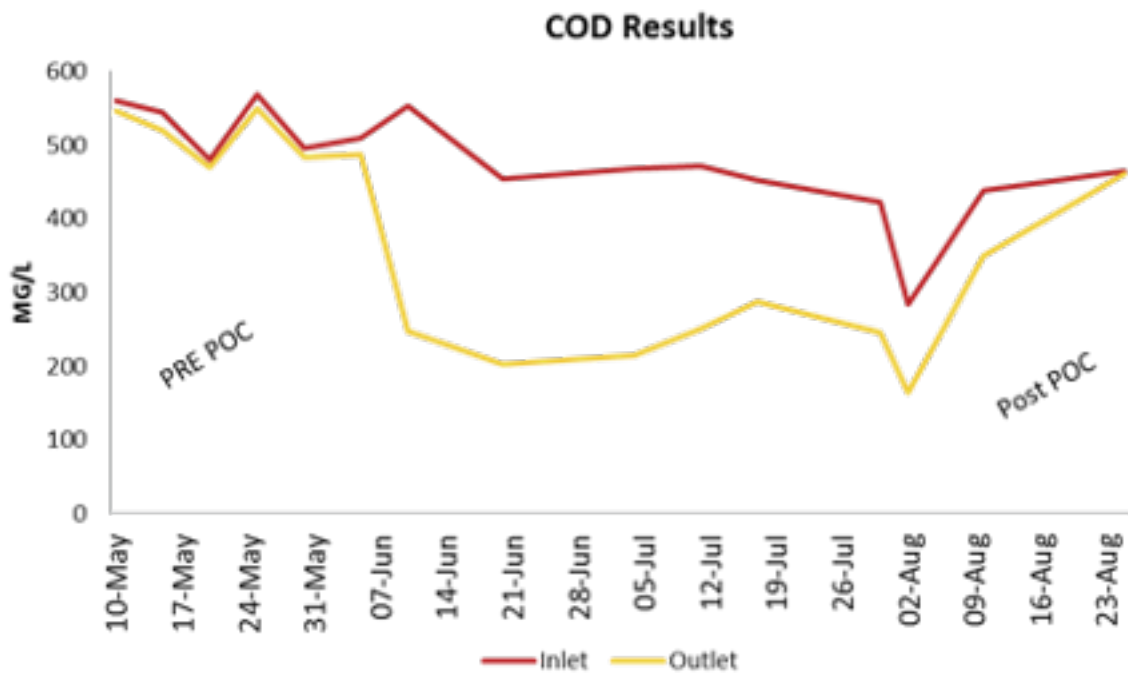
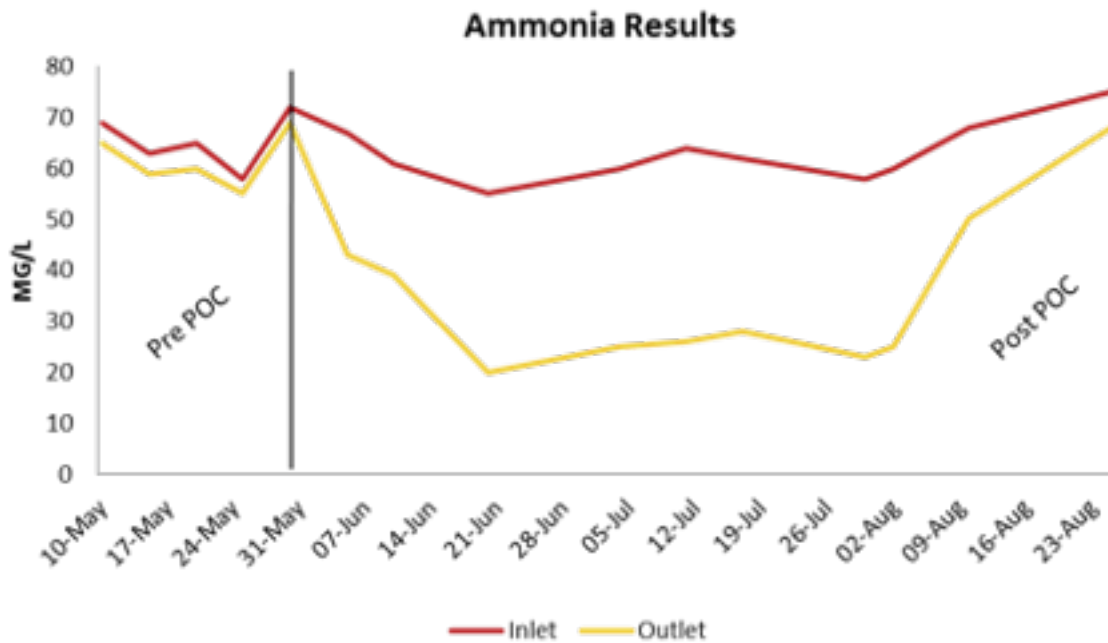
- Observations revealed that there was a substantial improvement of the effluent quality (BOD approx. 55%, COD approx. 56% and Ammonia approx. 64%).
- Bio2pure® solutions further improved the efficiency of the plant to accommodate large flow volume, for e.g. the plant capacity of Panipat was 35mld but it was observed that the flow received was 50mld, dosing mode was not altered during that time.
- Bio2pure® products improved the quality and effluent by:
 - Reducing foul odour
 - Reducing BOD
 - Reducing Ammonia level
 - Reducing COD

The above results were obtained under the following conditions prevailing at site:

- Sludge had not been removed for several years
- Maintenance of the Plant was poor
- Any treatment occurring was due to the bacterial inoculums; not the treatment system of the plant
